Alabama NRCS

Tech News

Winter 2008

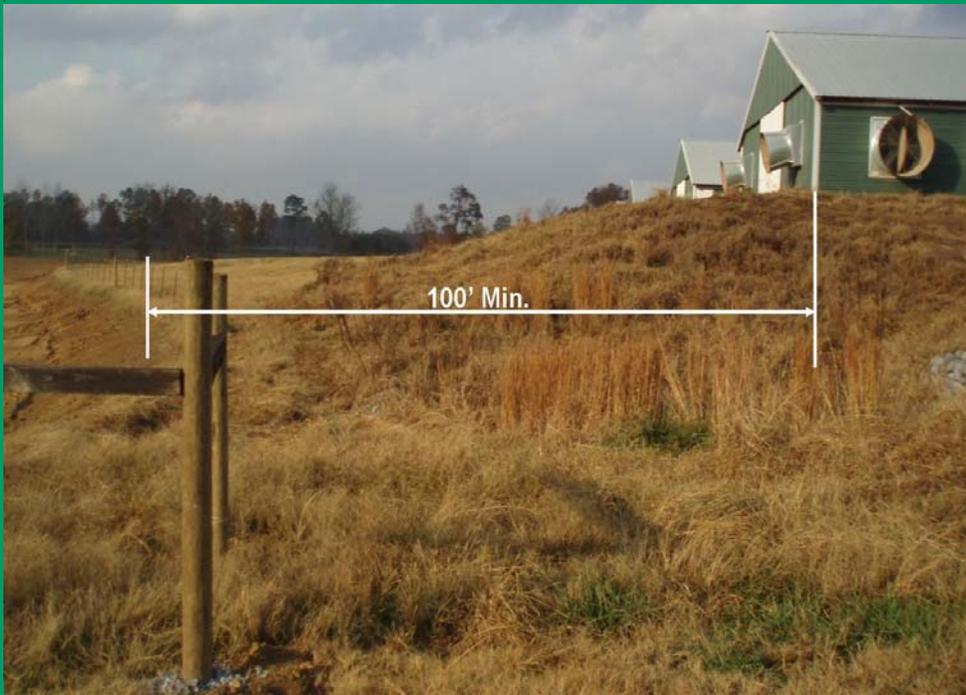
The appropriate minimum buffer distance in this case is 100 feet horizontal from the house corner to the normal waterline of the new pond.

The summary is too extensive to include here, but we will consider one frequently occurring situation for an example. This is the required buffer distance of a minimum of 100 feet between animal production facilities and water or sinkholes. This is a horizontal distance measured between the closest edge of the facility (corner of a building, edge of an incinerator, or composter pad, etc.) and the nearest edge of a waterbody (top of streambank, normal pond waterline, edge of sinkhole, wellhead, etc.). This buffer distance is to

be observed regardless of whether the facility or the water exists first. The intended use for this type of buffer requires that the soil in the buffer be covered with close growing permanent vegetation.

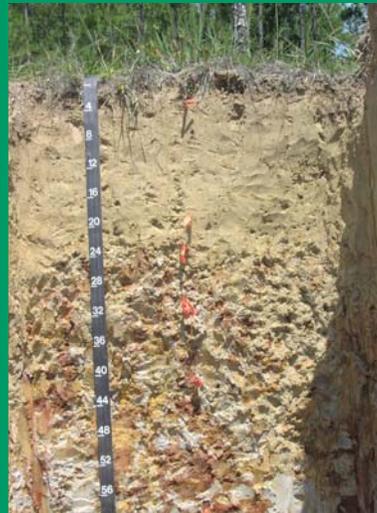
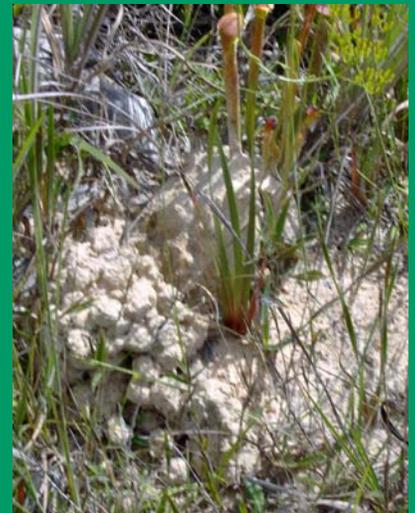
Tibbie Soil Profile (l) and Pitcher Plants and Carolina Red Root on Tibbie Soil surrounded by crawfish mound.

Several surface and subsurface soil profiles were exposed showing that this area contained dominant obligate and facultative vegetation and that this poorly drained soil had hydric and non-hydric characteristics.

We discussed the definition of a hydric soil. As with the Tibbie site, there were obligate plant indicators, such as Pitcher Plants scattered throughout the landscape. This was also a great visual exercise to show how quickly soils can change in their criteria across the landscape.

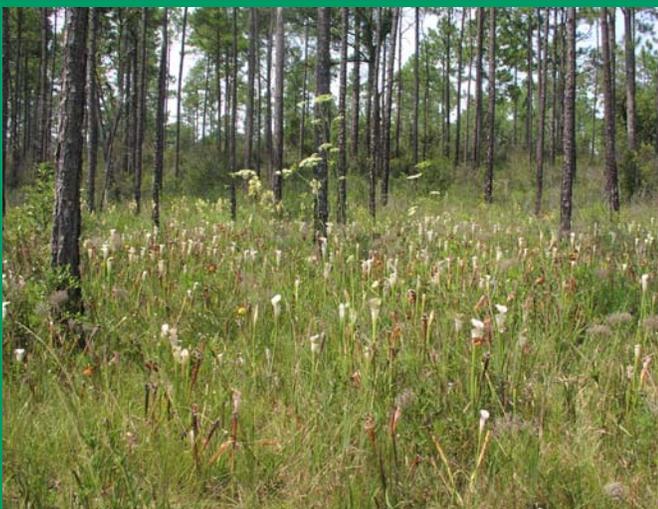
Tibbie Soils Landscape with Pitcher Plants in a 20-year-old stand of struggling pines.

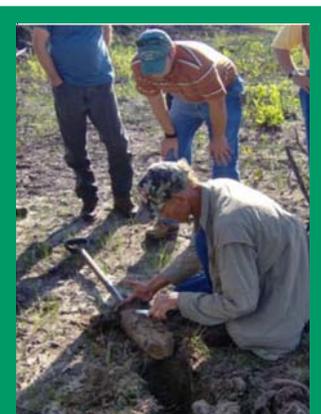
Wade Hurt demonstrates hydric soil indicators.

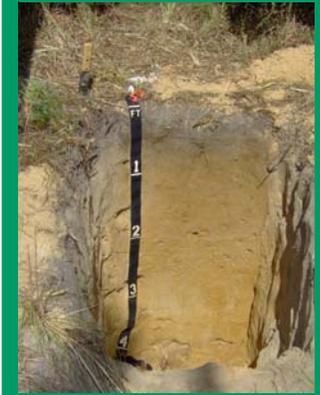
Blanton soil pit and profile. (below) Protected Gopher Tortoise found living in burrows on these sandy soils.

These soils are somewhat excessively drained to moderately

well drained with moderate to slow permeability. They are classified as Grossarenic Paleudults. These sandy soils have between 40 inches to 60 inches of a sandy upper layer before seeing an increase in clay content.

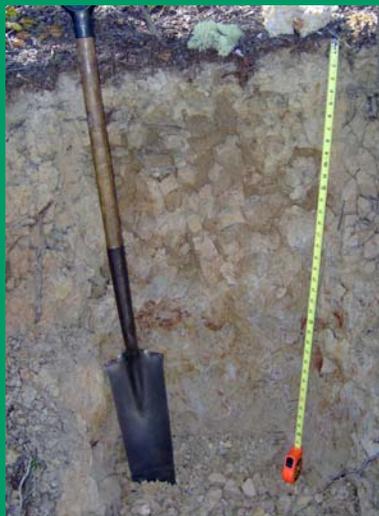
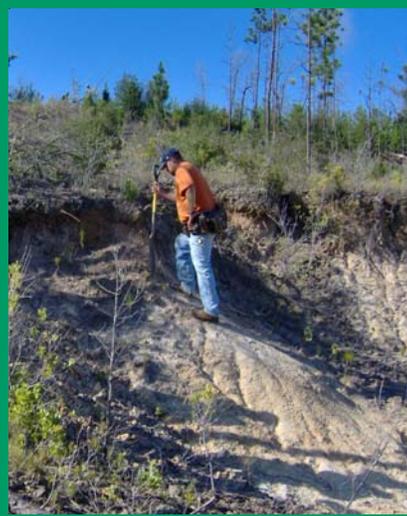
(l) Maubila Soil Profile showing its subangular blocky structure and iron depletions (gray colors) and iron accumulations (brown and reddish colors). (r) The steep Maubila Landscape.

On Tuesday, our first stop was to view a Maubila Soil Series that is found along many of the steeper areas throughout Washington County. They are also known to be found along short choppy side slopes, upland ridges, and knolls in the Southern Coastal Plain. This soil is oftentimes found in conjunction with a complex of soil types. It is a moderately well drained soil that has slow permeability. They are

classified as an Aquic Hapludults. This is not the kind of soil one would initially seek out to place a house or plant crops. It will, however, grow a decent stand of hardwoods and pines.

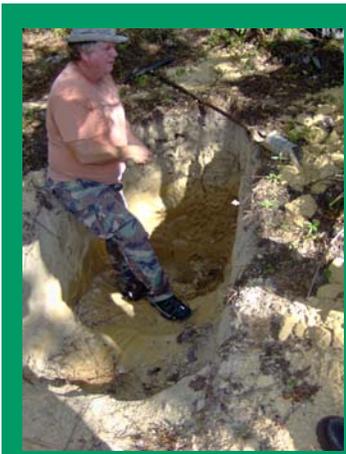
SDQS Greg Brannon approves the Olla Profile.

The final stop for Tuesday was to take a look at an Olla Series. These soils are found along highly dissected uplands in the Southern Coastal Plain. They are well drained soils and moderately permeable. They are classified as a Typic Hapludults and associated with Maubila soils in Washington County.

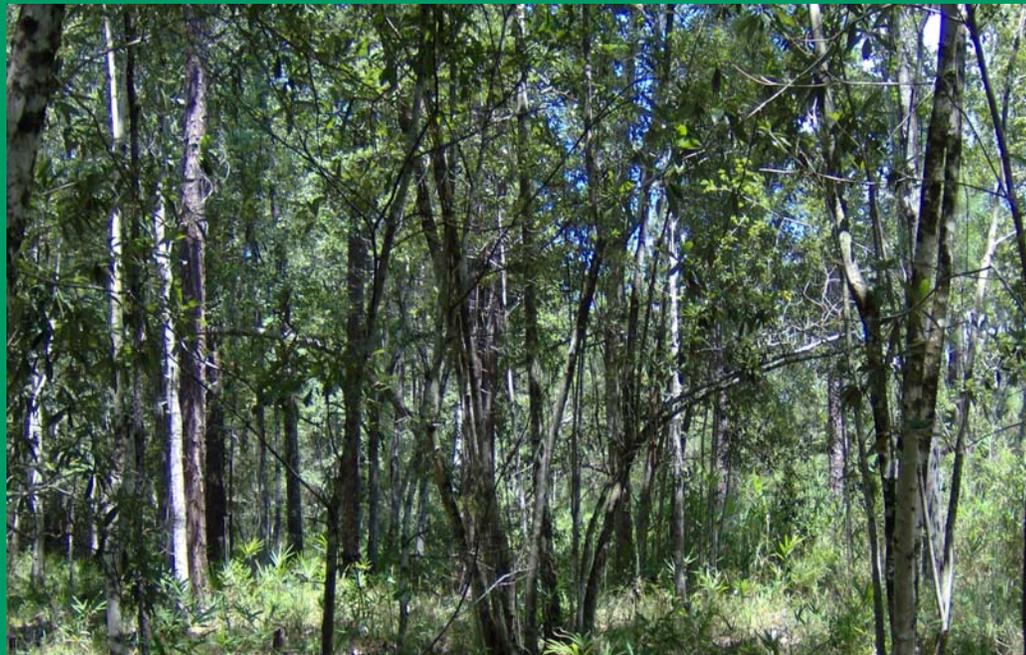
Example of vegetation that dominates areas of Bibb and Johnson soils.

For the rest of the day, we viewed some wet Bibb and Johnston Soil Series sites in flood plains.

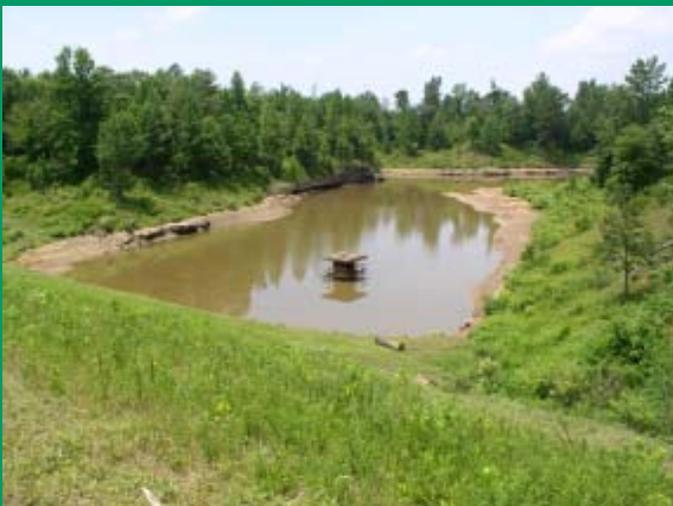
Watershed dam in July 2006 before problem.

The condition of the reservoir was compared to that of July 2006, when annual mowing maintenance was completed. The photo below shows that the pool level was very low and the riser was exposed several feet above the water level. At that time, it was noted that the valve, located at the bottom of the riser near the pool floor, appeared to be leaking, allowing the water level to drop. Also, the access hole to the inside of the riser was open and the trash rack was in need of repair or replacement.

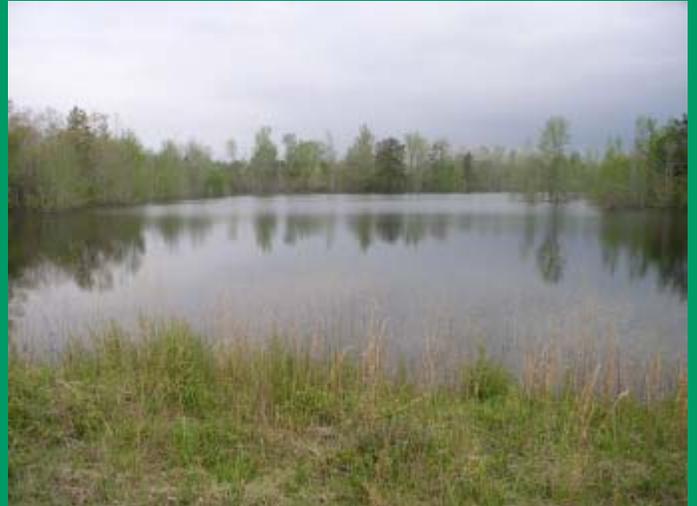
Riser completely under water in April 2007.

Little New River Site #2 is one of the oldest watershed dams in the state of Alabama. Located on Bostick Creek near Brilliant, the dam was completed in 1960. Its primary purpose is flood protection and prevention, but during an inspection in April 2007, a problem was discovered. The reservoir was full. It was up to the crest of the emergency spillway, as much as 20 feet above normal pool level, even though recent rains had been minimal. In addition, there was very little flow through the principal spillway pipe, leading the NRCS engineer to surmise that something (woody debris,

leaves, concrete, etc.) was clogging the riser.

failure of the dam. The Marion County Commission immediately secured and installed a 6-inch siphon pipe and began drawing down the reservoir so that the riser could be inspected. Several weeks of siphoning dropped the water level several feet; however, the top of the riser was still more than 10 feet below the surface.

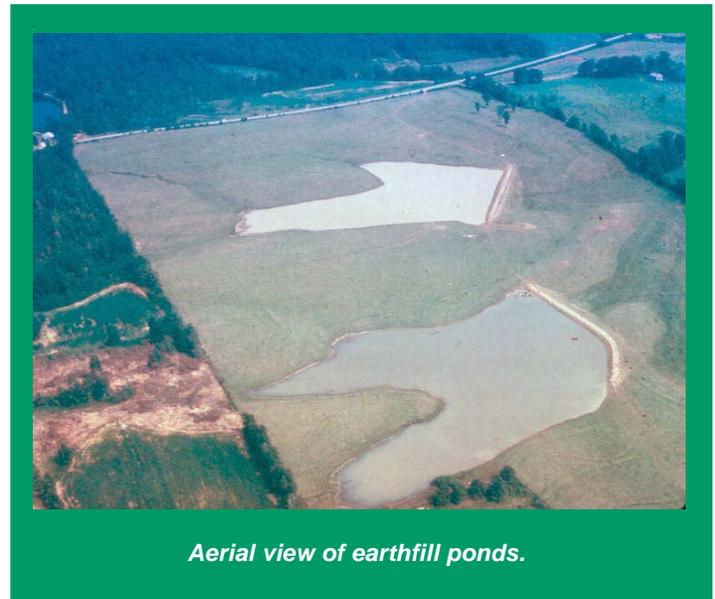
Aerial view of earthfill ponds.

For an earthfill pond (i.e. ponds that have an embankment) the process of developing a water budget is more difficult. A survey is

needed to develop stage/storage (i.e. elevation/surface area size) data. A waterline is surveyed (8 feet minimum depth) and the drought elevation (4 feet lower than the surveyed waterline) is checked to determine if the pond is "commensurate". In other words, storage at the drought level is considered available water for irrigation or livestock purposes.

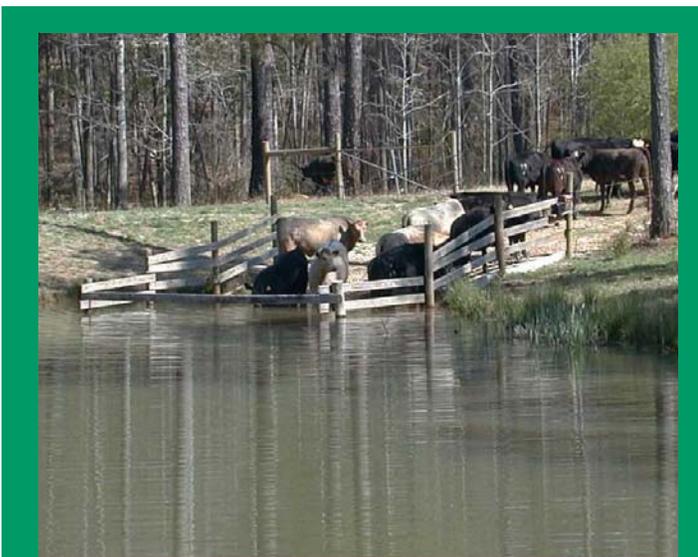
Pond constructed for the purpose of supplying water to livestock.

For excavated ponds (i.e. ponds that are "dug out"), developing a water budget is a simple process. A Microsoft Excel spreadsheet is used and the number of cattle, storage period, surface dimensions, desired depth and slopes are inserted. The program will then calculate the total storage required (sum of water needs and evaporation losses) and the designed storage. When the designed storage is equal to the total storage required, the pond is "commensurate" with the size of the operation.

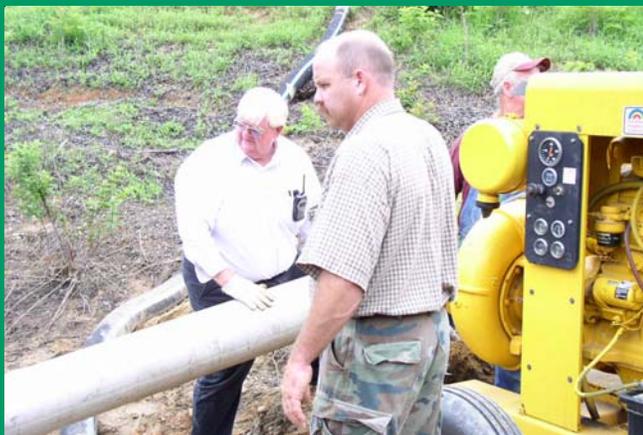
(l-r) County Commissioner Bob Bureson and NRCS District Conservationist Wade Hill assemble intake for the 10 inch irrigation pump.

local landowner provided the use of two 10-inch irrigation pumps, in addition to the two 6-inch pumps the county had rented. County
