Hole in Mountain SNOTEL Rebuilt in New Location

Reno, Nevada – Dec. 13, 2016 – Hole in Mountain SNOTEL, south of Wells, Nevada in the East Humboldt Mountains, was rebuilt in a new location and brought back online on October 20, 2016. The weather station had not reported data since it was destroyed by an avalanche on December 23, 2015. This was the second avalanche to hit the SNOTEL. The first avalanche was in February 1986, after which the site was rebuilt in the original location. This time, the station was moved about 450 feet south and located behind a small ridge to protect the site from future slides.

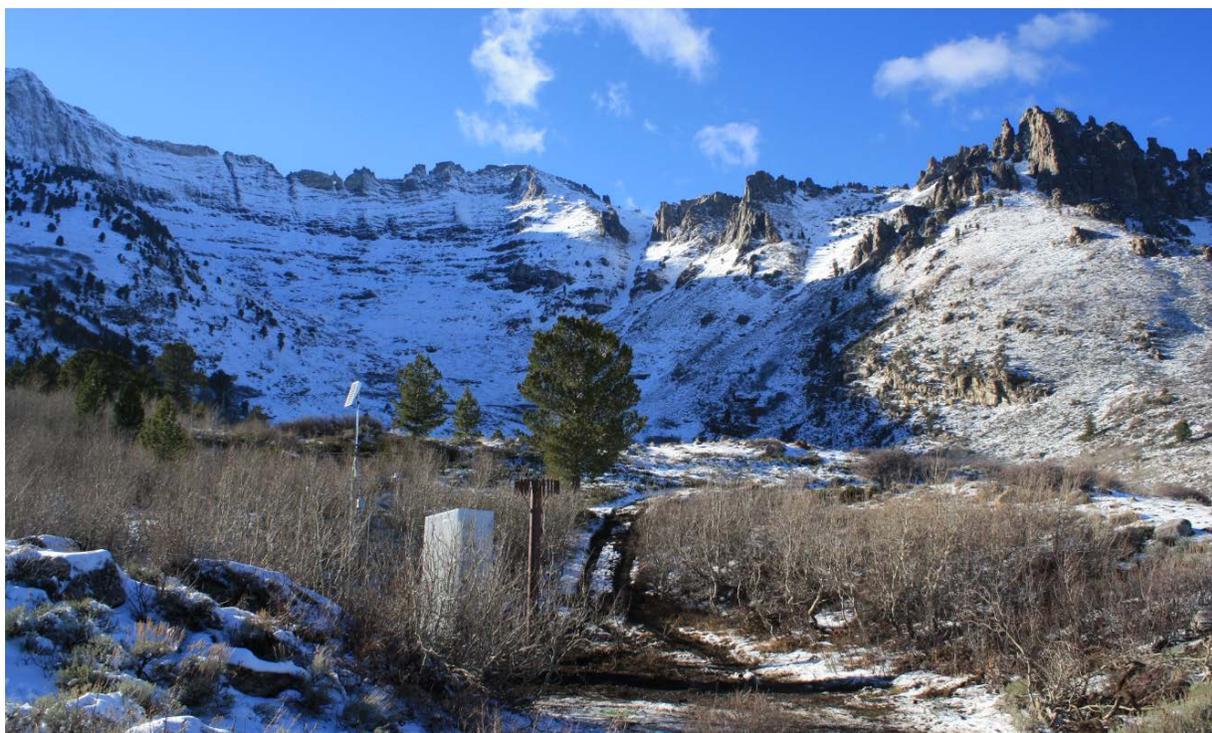
Photo 1: Hole in Mountain SNOTEL in its new location. The site is tucked behind a small ridge about 450ft south of the original location. This new location will keep future avalanches from impacting the site. Photo taken October 2016.

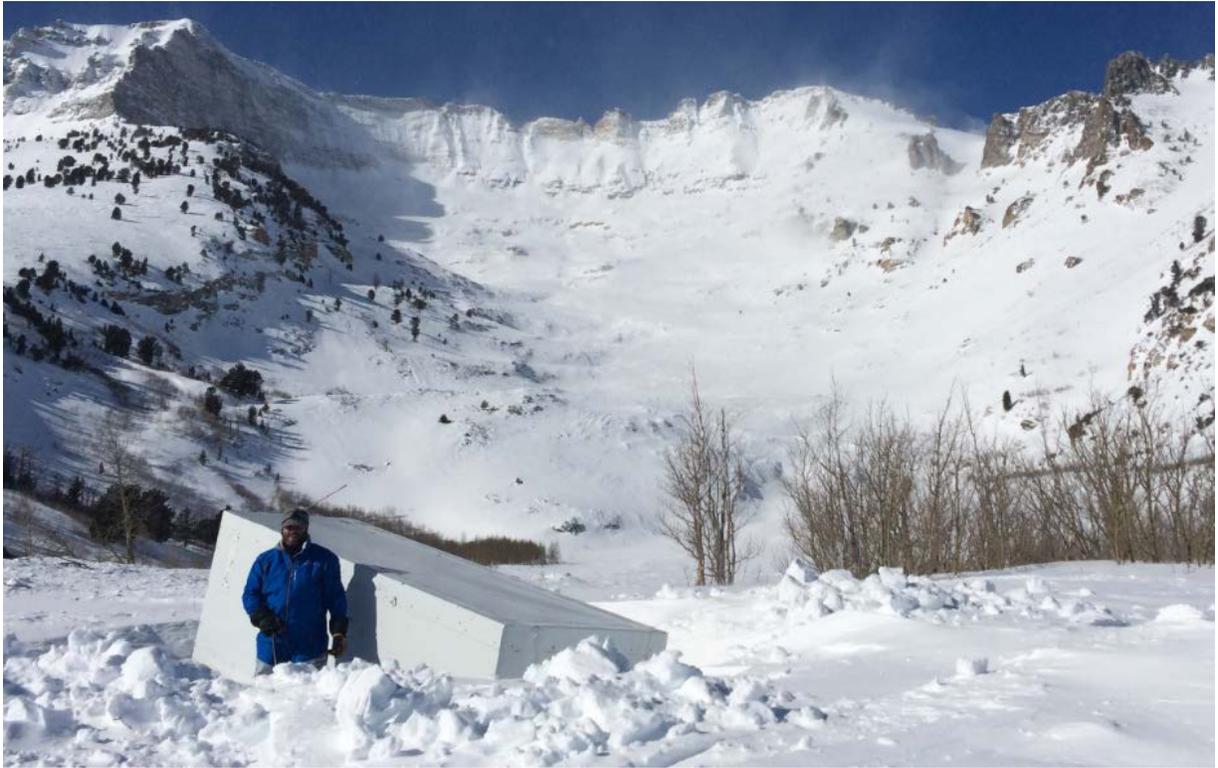
Photo 2: Damaged observed at Hole in Mountain SNOTEL after avalanche. The SNOTEL shelter, which houses the site's electronics, was swept 200 feet downhill of its foundation. Photo taken January 2016.

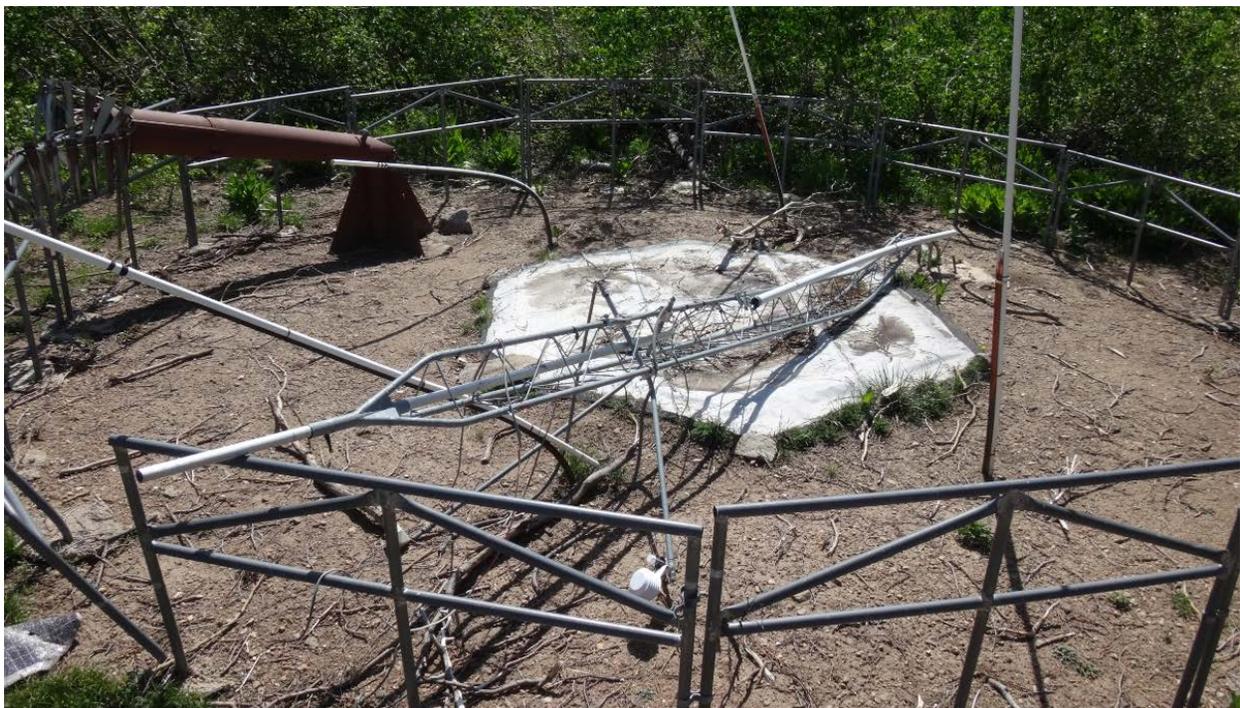
Photo 3: Damaged observed at Hole in Mountain SNOTEL after melt-out. The avalanche bent over the brown precipitation gage and instrument tower. The snow pillow which weighs the snowpack is the white object under the tower. Photo taken June 2016.
